Fish-Passage Field Findings

April 2019

Lessons Learnt 01: Retrofit of an existing fish pass with flexible baffles to improve fish passage for all species.

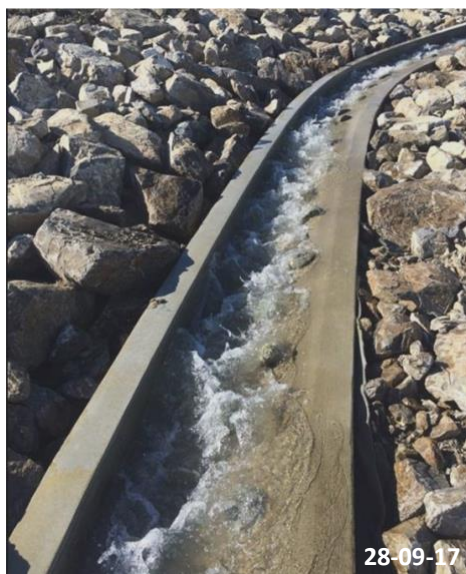
The original fish pass design, installed in June 2017, considered fish passage by providing a 107 m long by 500 mm wide by 200 mm deep, angled fish “ladder” over a dam wall in Saxton Creek, Nelson, NZ (Figure 1). Rocks were embedded into the concrete ladder with the aim of slowing the flow and introducing nature-like flows.

Unfortunately, the fish pass effectiveness appeared to be poor with concerns post construction including:

- High velocity water in long sections of the fish pass was likely a barrier to fish movement.
- There was a lack of low velocity areas for fish to rest as they migrate upstream.

No fish were observed using the fish pass.

Figure 2. Failed fish pass

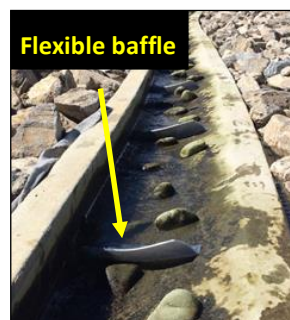
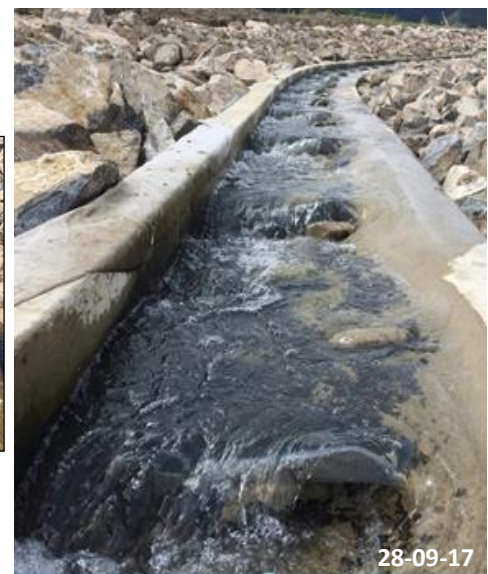
Figure 1. Retrofitted Fish Pass

Eighty flexible baffles were installed to further reduce water velocity and break up the flow (Figure 1). These baffles were fabricated to fit the triangular design of the fish pass and offset 50 mm from the deep edge of the channel to allow for passage in low flows. Baffles were 450 mm wide and 100 mm high with 45-degree cuts at both ends to allow fish passage around the baffle (Figure 2).

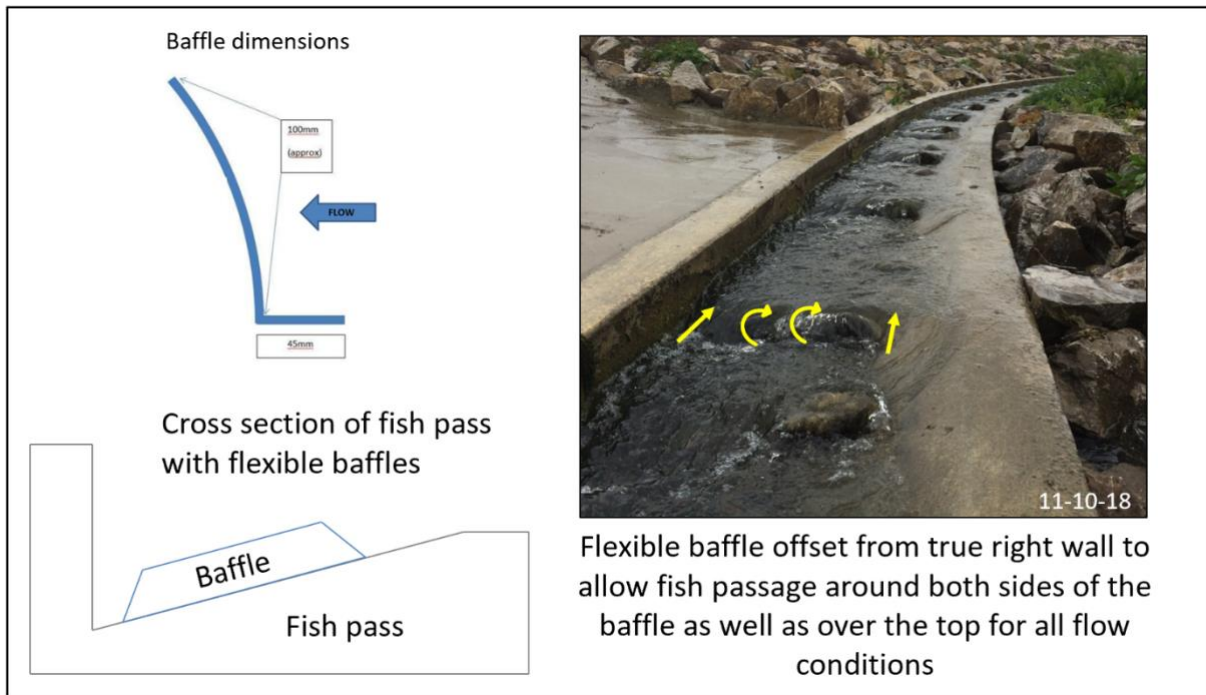
Figure 2. Flexible baffle dimensions and positions within the fish pass

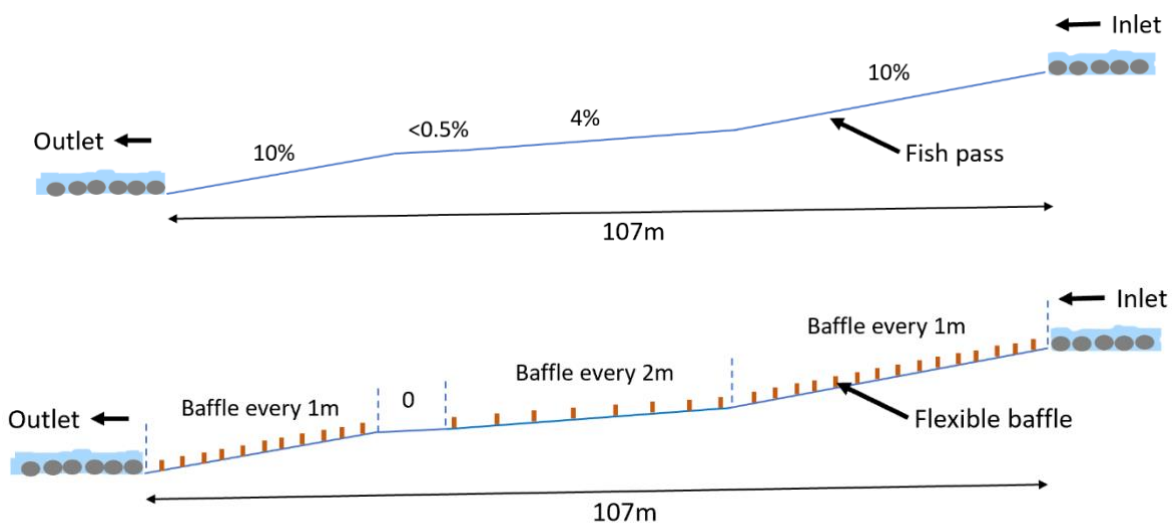
Figure 3. Cross sections of the Saxton Creek fish pass showing the changes in gradient (top) and the spacings between baffles (bottom)

Baffle spacing’s were determined based on the grade of concrete (Figure 3). Grades throughout the fish pass ranged from <0.5% to 10%. Baffles were installed within the fish pass except where grades were <0.5%. Water velocities through the low-grade section (<0.5%) were not considered a barrier to fish. Baffle placement was limited to areas where rock was not embedded. As a result, spacings between baffles did vary.

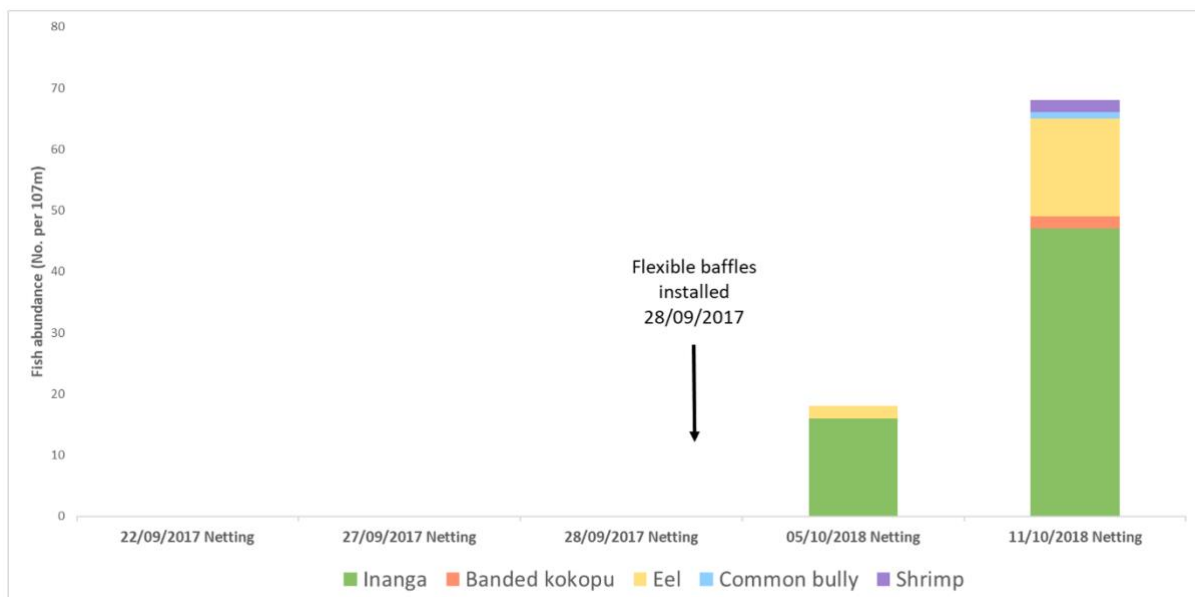
Two surveys using hand nets were conducted one-year post-baffle installation over the entire fish pass. This involved “guiding” fish to a downstream stop net repeatedly over short distances e.g. between two baffles at a time. Overall, fish species and abundance were noticeably different to pre-baffle installation within the fish pass (Graph 1).

Graph 1. Results of fish abundance monitoring in the Saxton Creek fish pass before and after baffle retrofit.

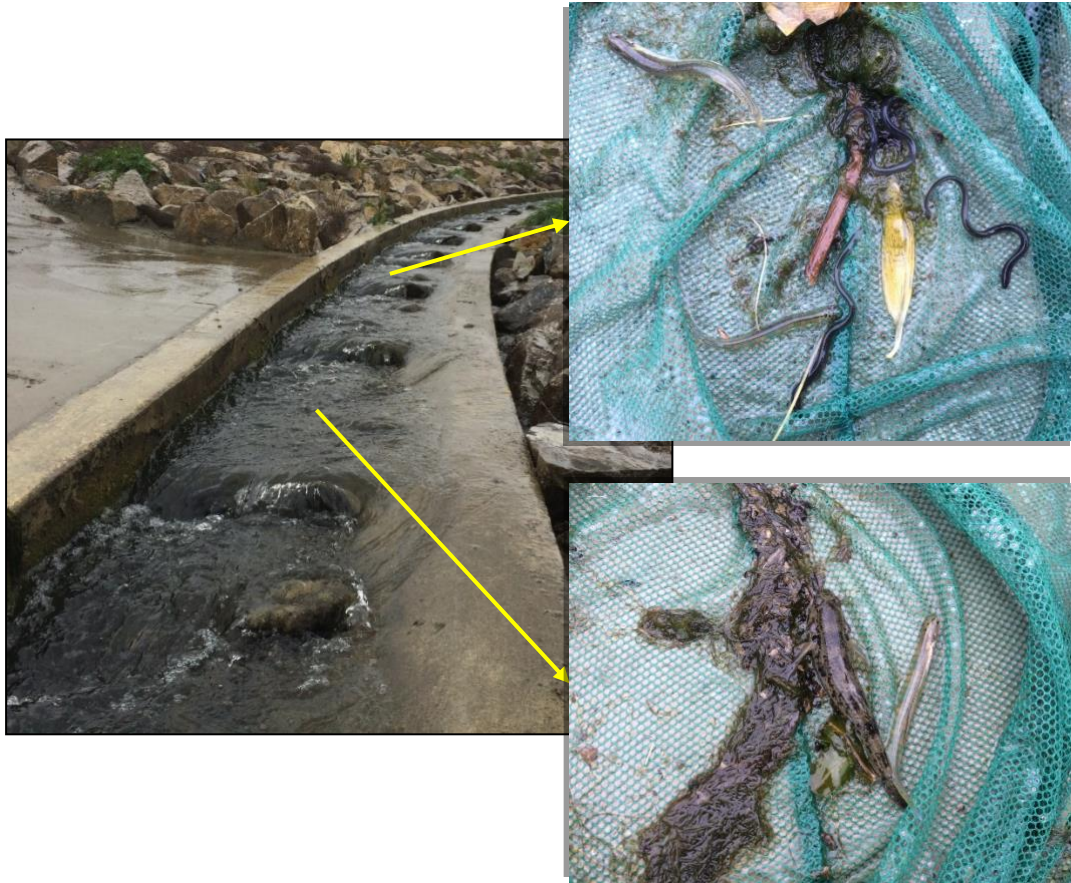
Figure 4. Fish caught during a hand net survey of the Saxton Creek fish pass on the 11-10-18. Species pictured above include inanga, eels and a common bully.
