Fish-Passage Field Findings

June 2020

Lessons Learnt 02: Flexi-Baffle installation to restore fish passage in a long, complex culvert

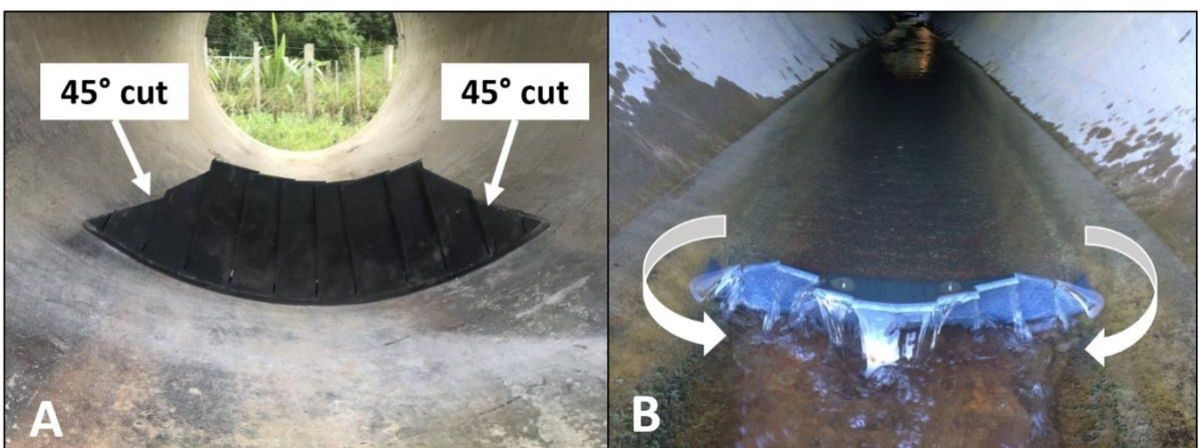
Figure 3. Each baffle is cut at 45° on either side (A) to allow water to spill around the baffle (B) enabling fish passage, even at low flows (Note: photographs are not from Reservoir Creek culvert).

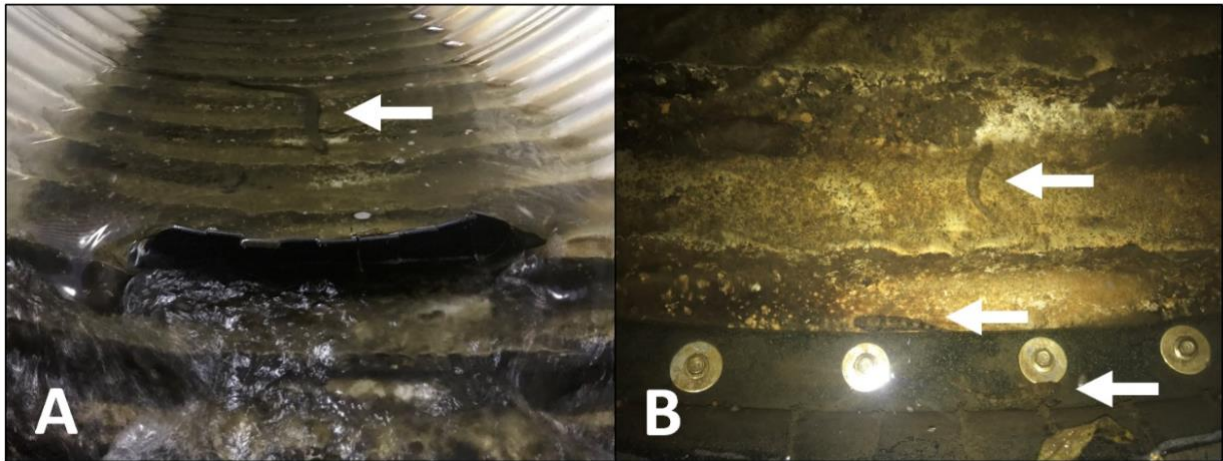
Several inspections within the culvert barrel have been carried out to assess baffle durability. During those inspections, anecdotal observations showed fish in pools between baffles and swimming upstream around the 45-degree cuts in the baffles and may be using baffles as refuge (Figure 6).

Figure 6. Photo A shows an eel in a pool upstream of a Flexi-baffle. Photo B shows three common bully in a pool upstream of a baffle near the top of the culvert.
