Fish-Passage Lessons Learnt

Retrofit of an existing fish pass with flexible baffles to improve fish passage for all species.

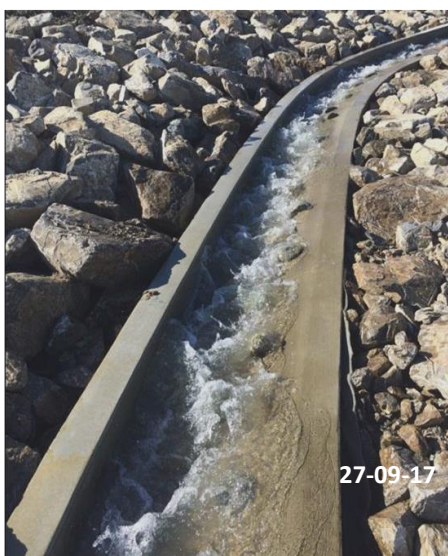
1 Failed Fish Pass

Unfortunately, the fish pass effectiveness appeared to be poor with concerns post construction including:

- High velocity water in long sections of the fish pass was likely a barrier to fish movement.
- There was a lack of low velocity areas for fish to rest as they migrate upstream.
- No fish were observed using the fish pass.

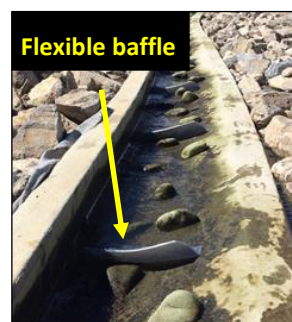
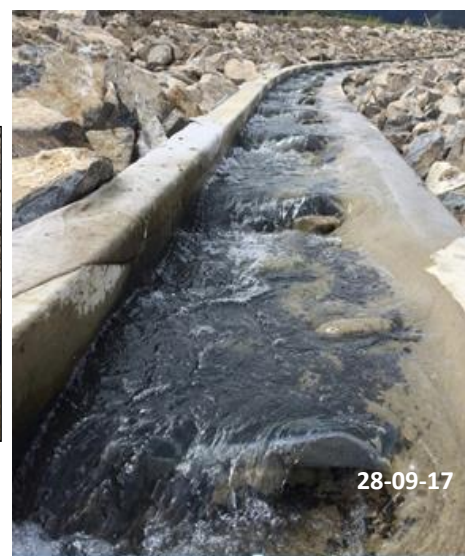
2 Remediated Fish Pass

One day after baffle installation, the fish pass was electric fished. Several inanga were found between the baffles within both the 4% and 10% gradient areas.

Eighty flexible baffles were installed to further reduce water velocity and break up the flow (Figure 1). These baffles were fabricated to fit the triangular design of the fish pass and offset 50 mm from the deep edge of the channel to allow for passage in low flows. Baffles were 450 mm wide and 100 mm high with 45-degree cuts at both ends to allow fish passage around the baffle (Figure 2).

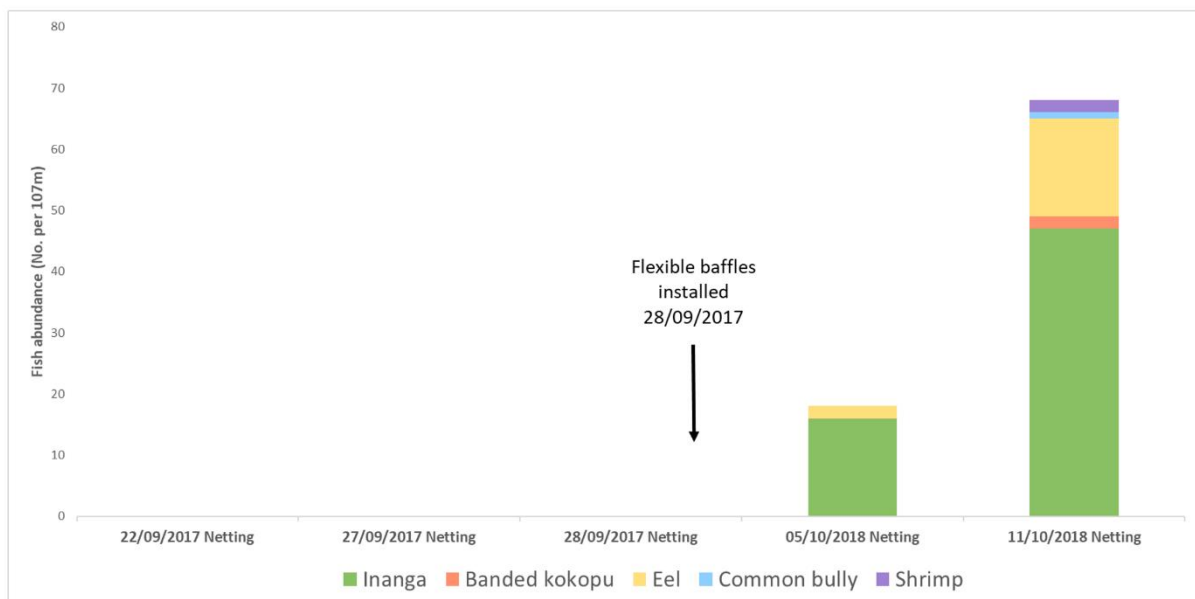
Graph 1. Results of fish abundance monitoring in the Saxton Creek fish pass before and after baffle retrofit.

Two surveys using hand nets were conducted one-year post-baffle installation over the entire fish pass. This involved “guiding” fish to a downstream stop net repeatedly over short distances e.g. between two baffles at a time. Overall, fish species and abundance were noticeably different to pre-baffle installation within the fish pass (Graph 1).
