Fish-Passage Field Findings

June 2020

Lessons Learnt 02: Flexi-Baffle installation to restore fish passage in a long, complex culvert

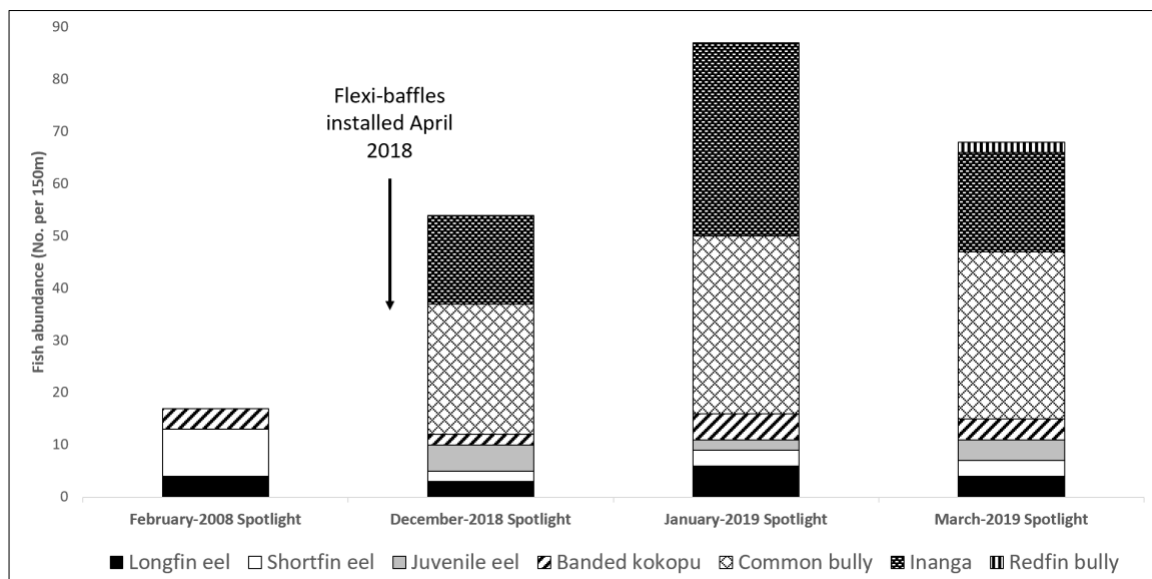
Fish communities within the 150 m reach directly upstream of the Reservoir Creek culvert were surveyed by Tasman District Council three times using single pass spotlighting over the 2018 / 19 summer, and once by single pass electric fishing in March 2020. These surveys can be compared to a single pass spotlight survey (February 2008), and two single pass electric fishing surveys (January 2012 and March 2016) of the same reach prior to any fish passage improvements (Figures 4 & 5). Results showed Inanga and redfin bully were found upstream of the culvert for the first time (Figures 4 & 5) and common bully numbers upstream of the culvert increased (Figures 4 & 5) following fish passage improvements. The minimum size of Inanga and common bullies was 50 mm and 40 mm, respectively, suggesting young fish are moving through the culvert.

Figure 4. Number of fish observed upstream of the culvert before (Feb 2008) and after (Dec 2018, Jan and Mar 2019) Flexi-baffles were installed.

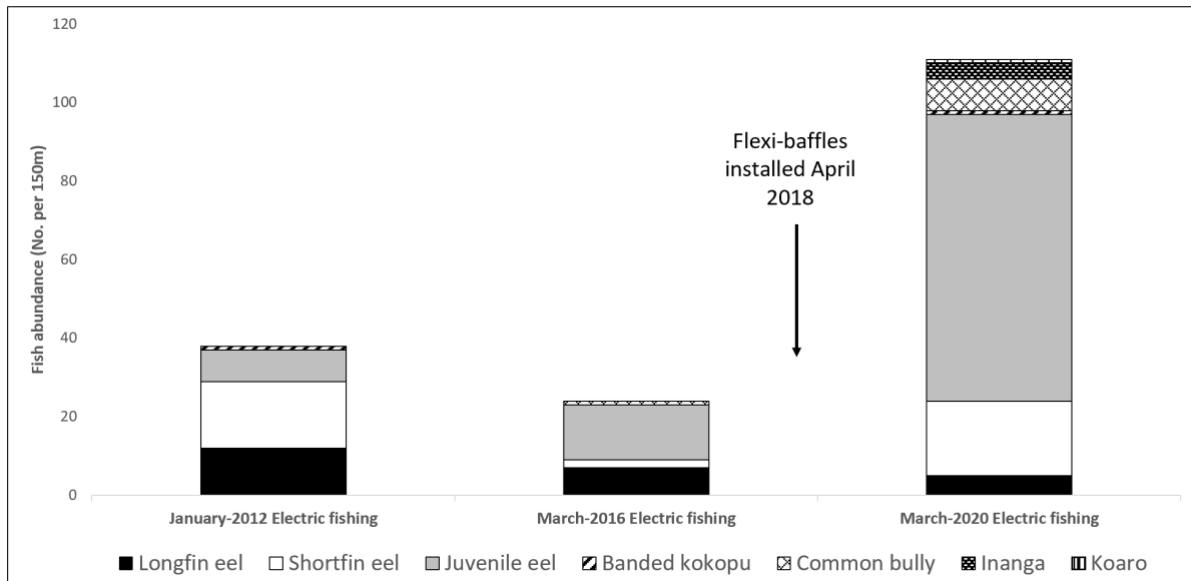
Figure 5. Number of fish observed upstream of the culvert before (Jan 2012 and Mar 2016) and after (Mar 2020) Flexi-baffles were installed.
